# Assessing and Monitoring Girth Gearing Wear

Bill Hanks, A-C Equipment Services, USA, explains why it is essential to minimise wear to girth gearing in order to achieve proper operation and maximise service life, and discusses the importance of an assessment and monitoring program.

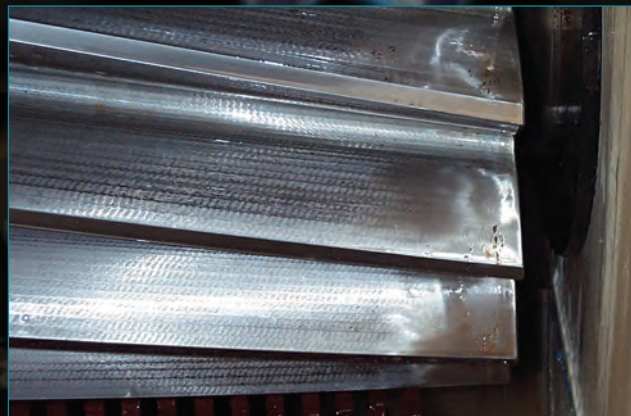
Figure 2. Pinion with original cutting tool marks. Polishing on right side is caused by misalignment.

Properly installed and maintained girth gearing teeth will have a smooth, dull, aluminum or brushed nickel appearance. There should be no signs of surface distress and the original tool marks from the tooth cutting (left side of Figure 2) should remain visible for many years.

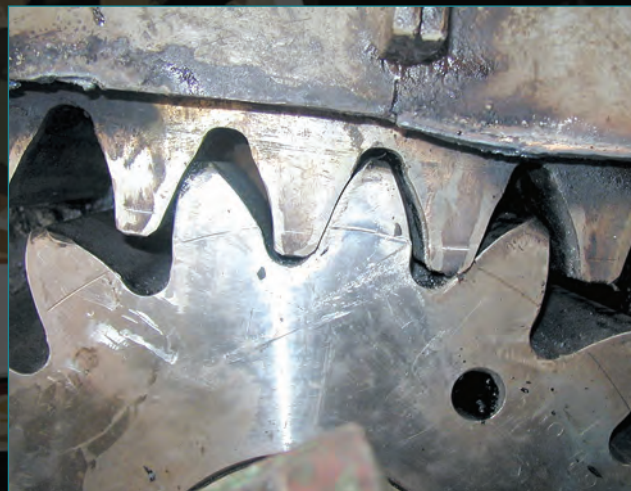
Figure 3. Severe gear profile wear.

When teeth are worn half-way through the top land thickness, the profiles will have become severely

worn (Figures 3 and 9). These profiles no longer have the original involute form. This creates mesh incompatibilities resulting in vibration, noise and very high localised stresses.

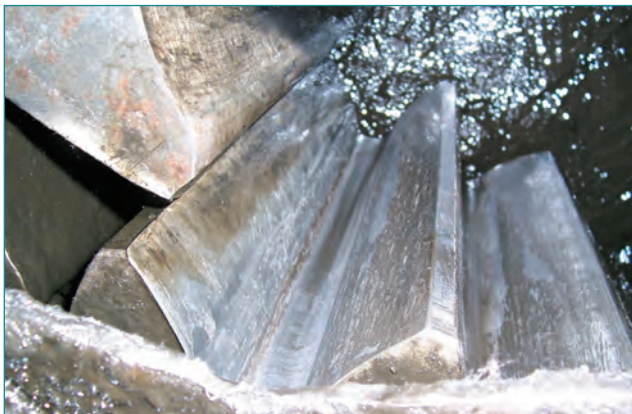
Figure 4. Mild pinion wear and edge plastic flow.

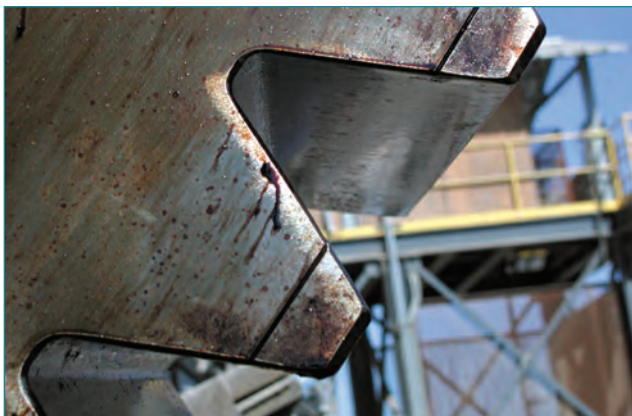
Figure 6. Mild gear profile wear and corrosion.

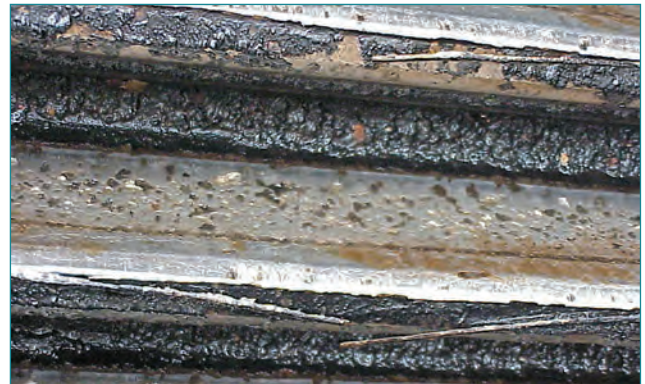
Figure 8. Severe plastic flow results in top land material separation. This material should be removed immediately to prevent debris going through mesh.

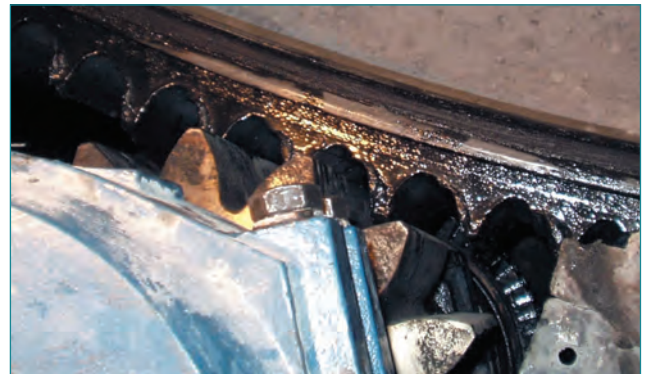
Figure 9. Very severe gear profile wear meshing with newer pinion. This gear should be replaced as soon as possible.

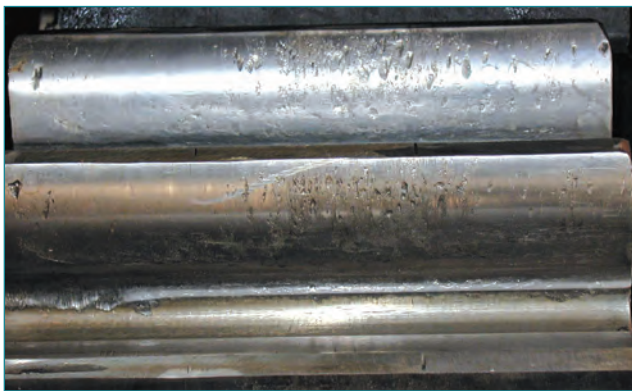
Figure 10. Polishing, debris denting, moderate wear.

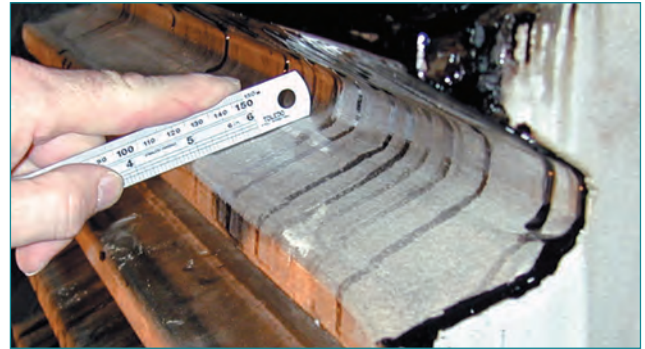
Figure 14. Worn tooth profile with straight edge showing concave shape. (Photo courtesy of The Falk Corp., Milwaukee, WI.)

New tooth profiles are outwardly curved or convex (Figure 14). Worn tooth profiles are recessed or concave. A simple straight edge can be placed against the tooth profile to determine if the profile is convex or concave (Figure 14). Some sites have even taken feeler gauge measurements to more accurately determine the magnitude of wear.
